Debris/Ice/TPS Assessment And Photographic Analysis For Shuttle Mission STS-43

September 1991

DEBRIS/ICE/TPS ASSESSMENT
AND
PHOTOGRAPHIC ANALYSIS
OF
- SHUTTLE MISSION STS-43

August 2, 1991

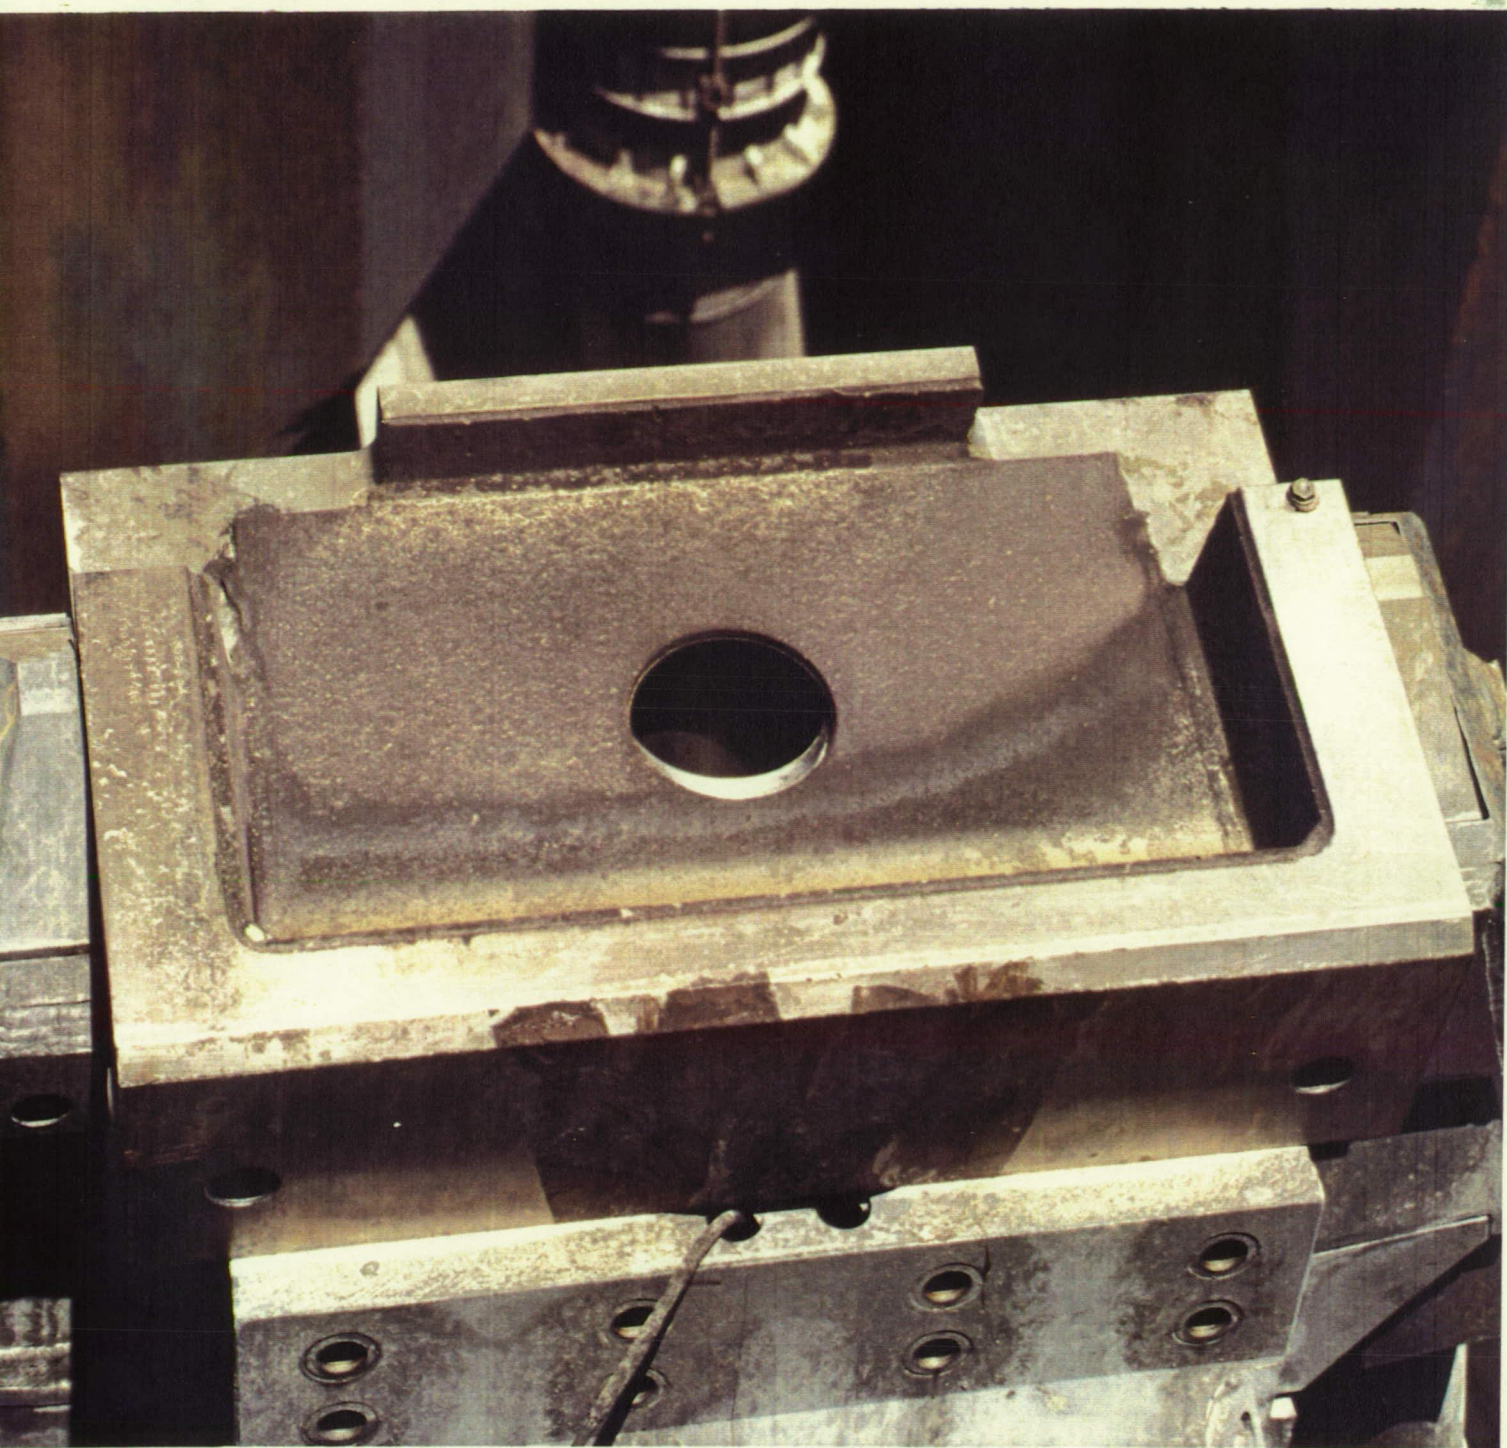
Plume erosion of the south SRB holddown posts was typical. All EPON shim sidewall material and shim bottom plate material was intact and bonded to the shoes. There was no visual indication of a stud hang-up on any of the south holddown posts.

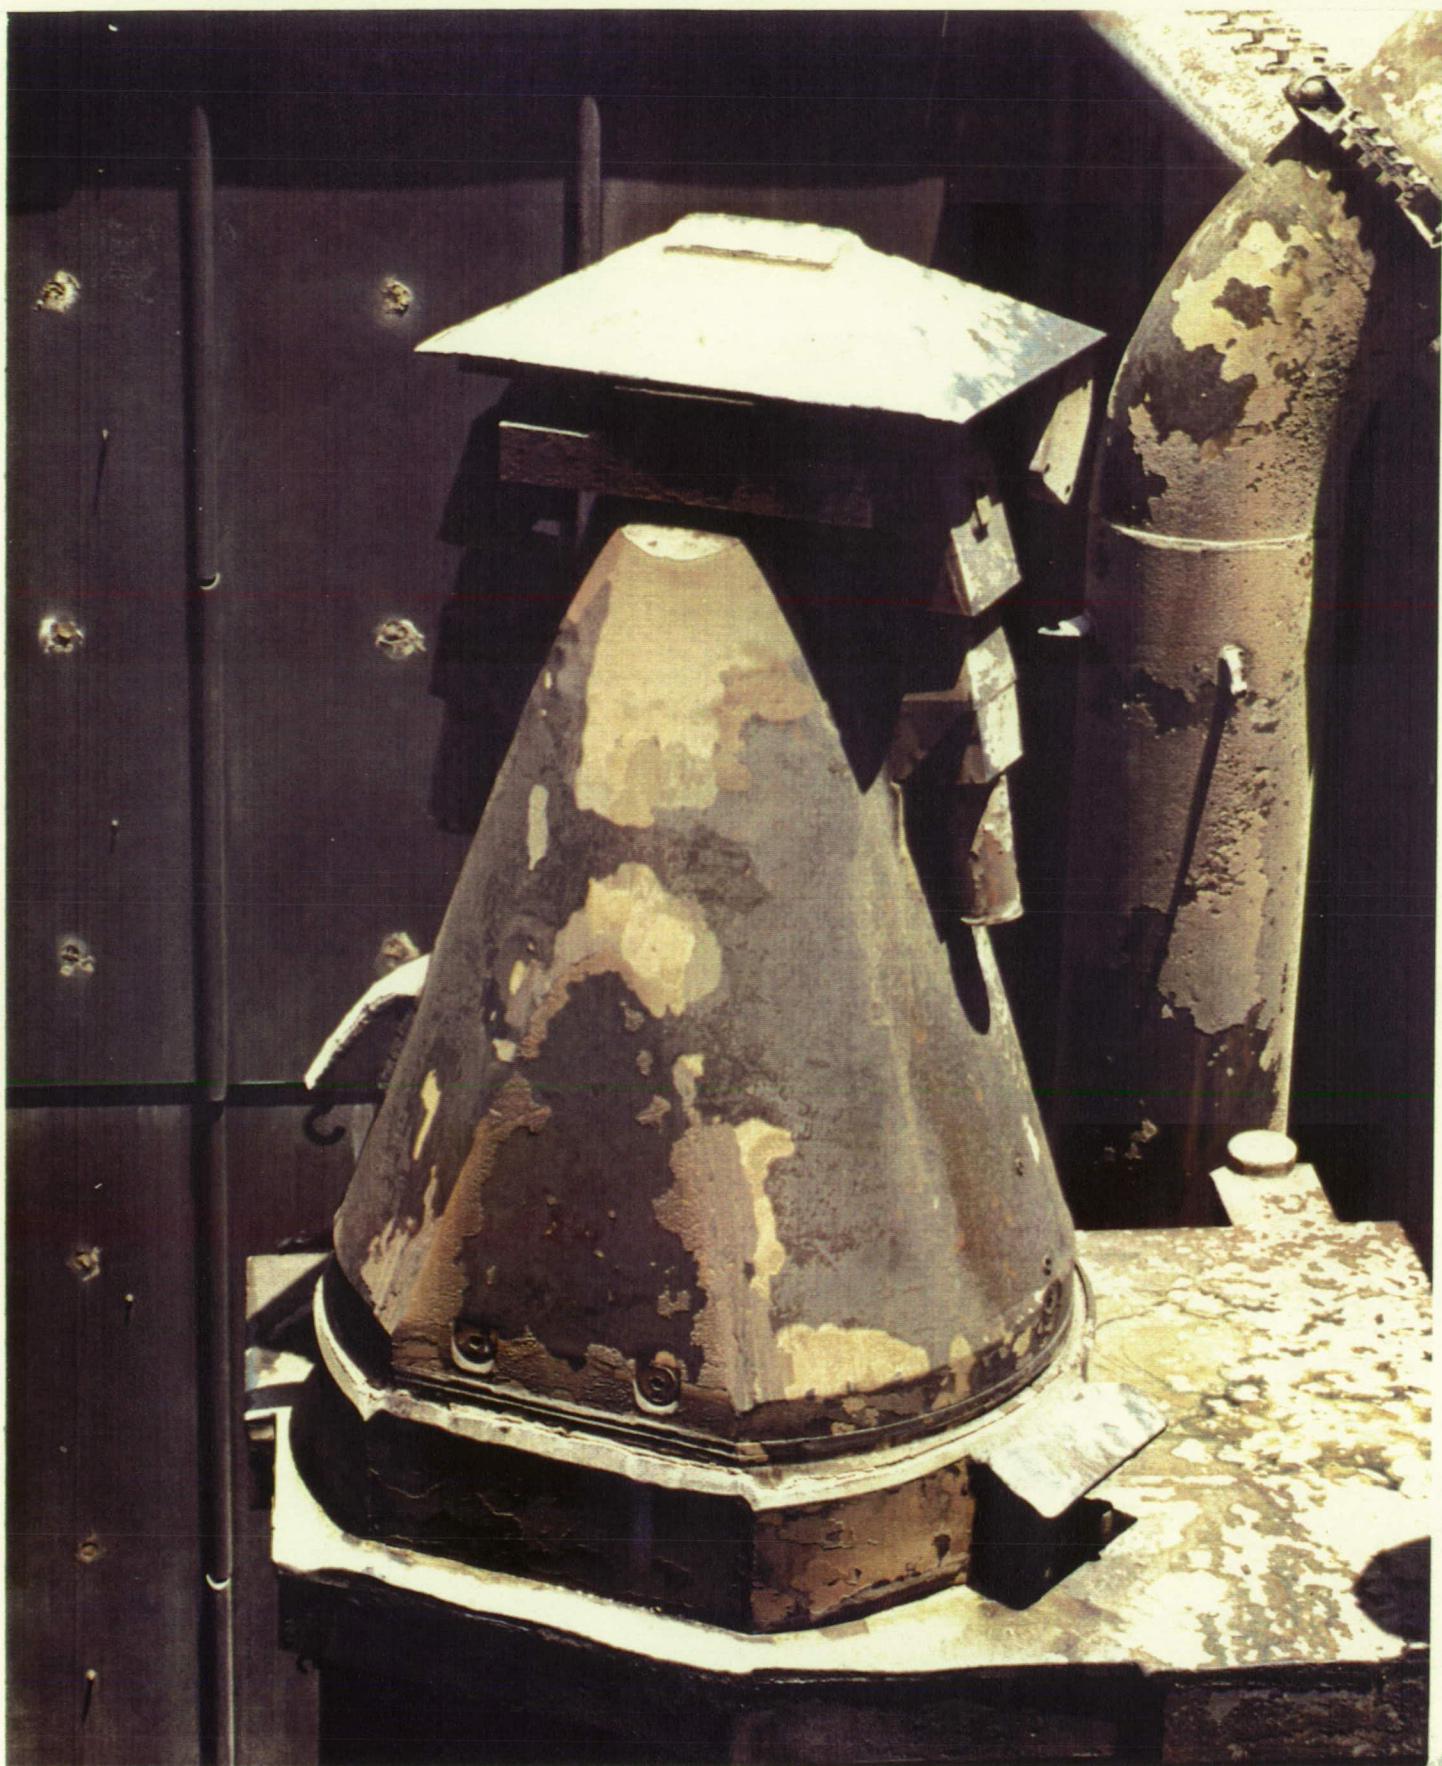
North HDP blast covers were in the closed position and exhibited typical plume erosion effects

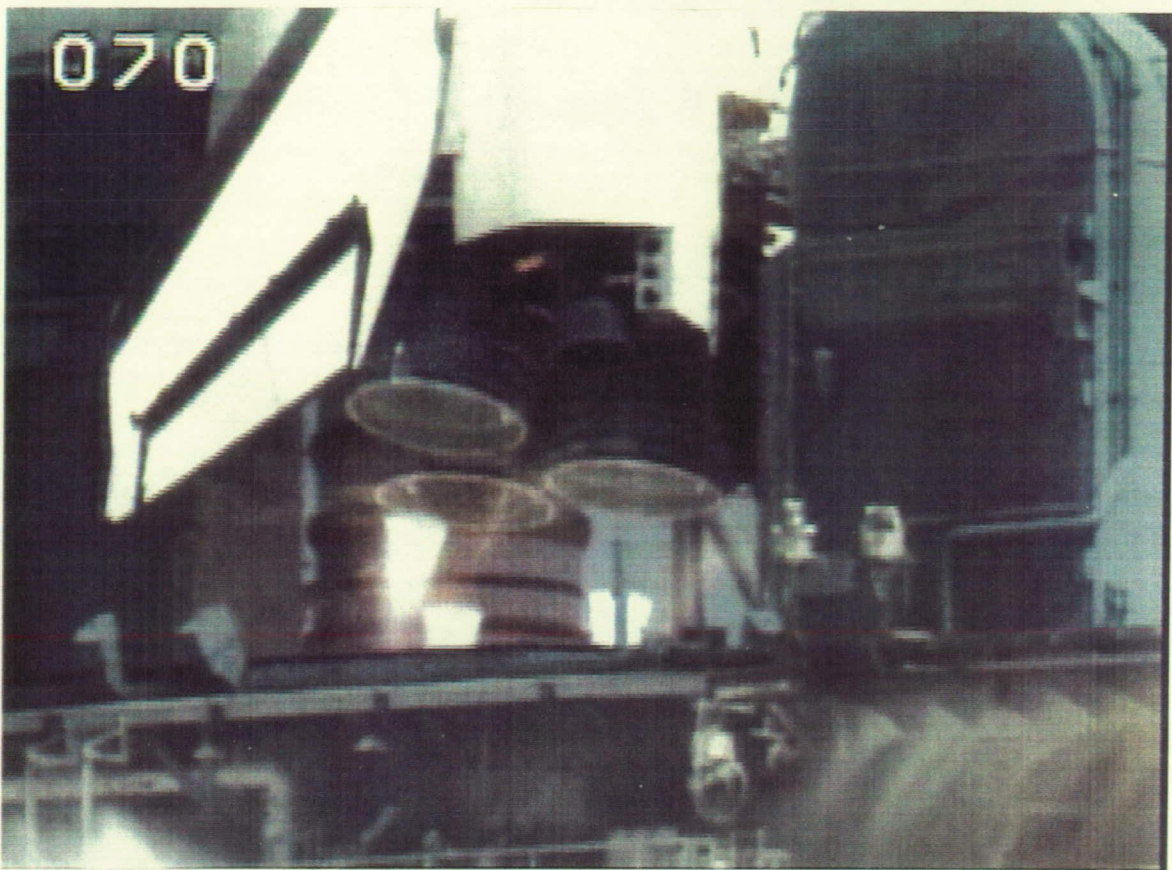
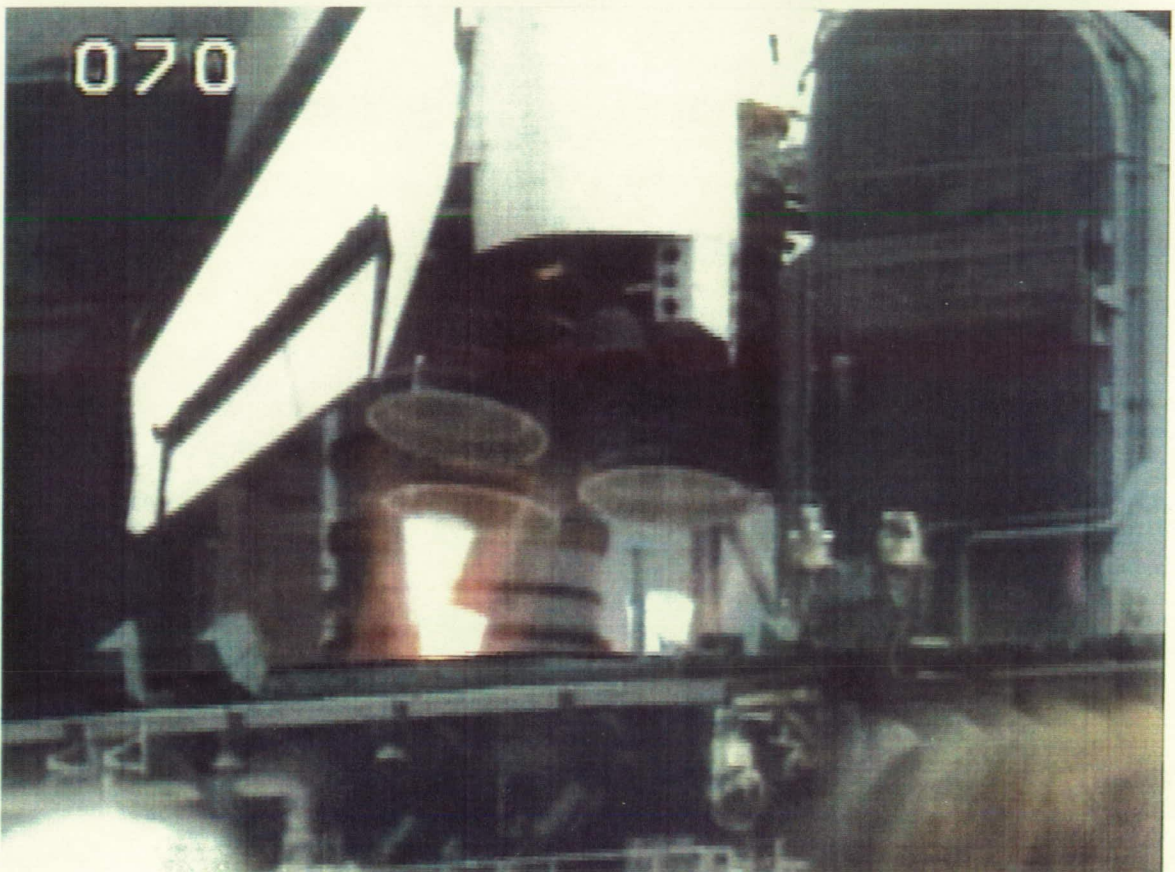
Initial SSME ignition and gimbal profile appeared nominal (top). Numerous flashes and discolorations, possibly caused by contaminants, occurred in the SSME #2 Mach diamond during ignition (bottom).

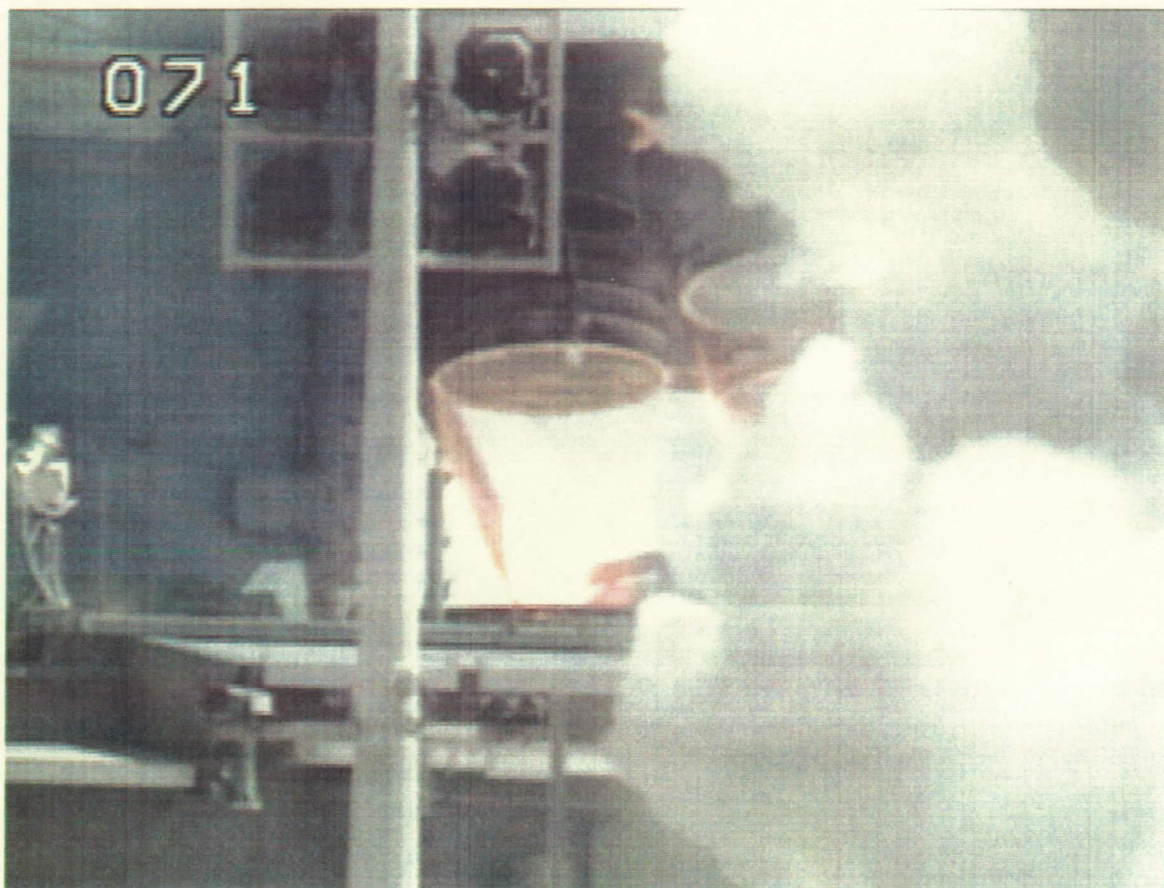
Orange streaks, typically caused by debris such as pieces of aft RCS paper covers, were visible on the edge of the SSME #1 plume

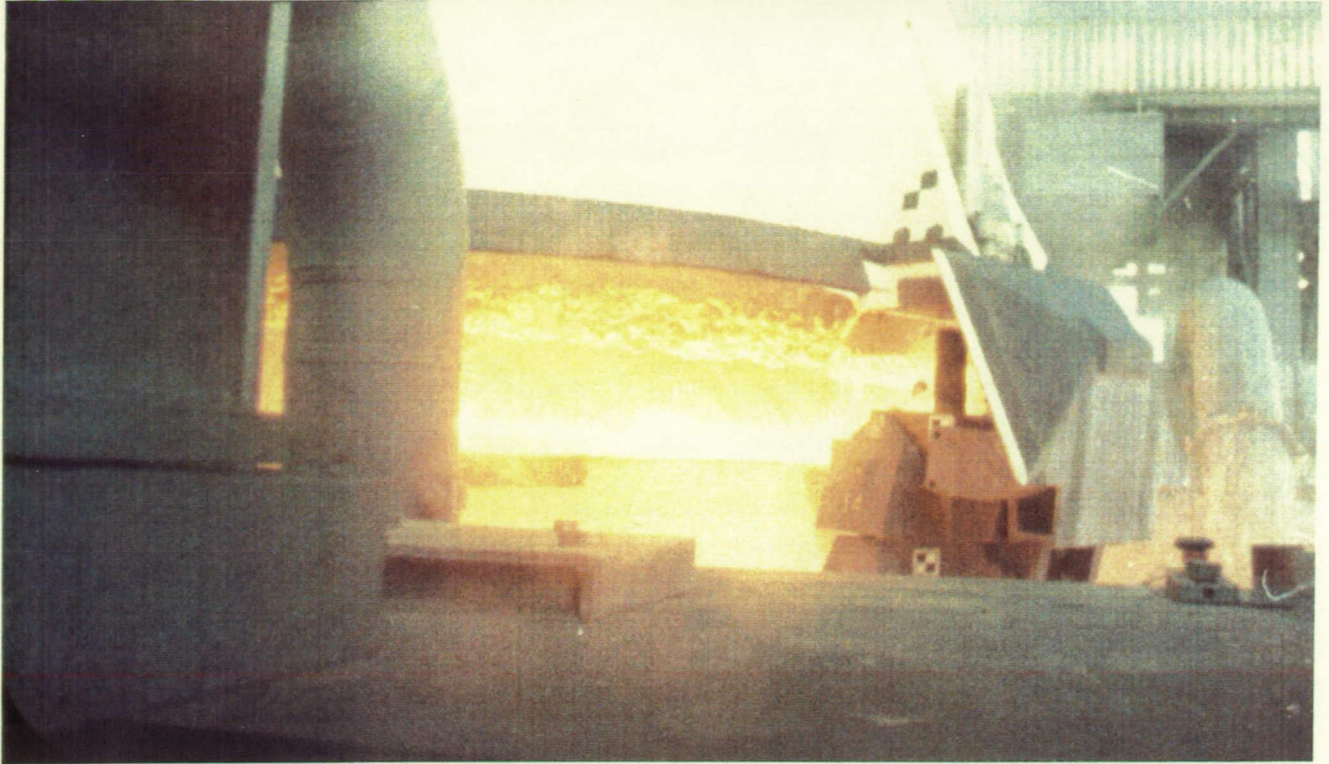
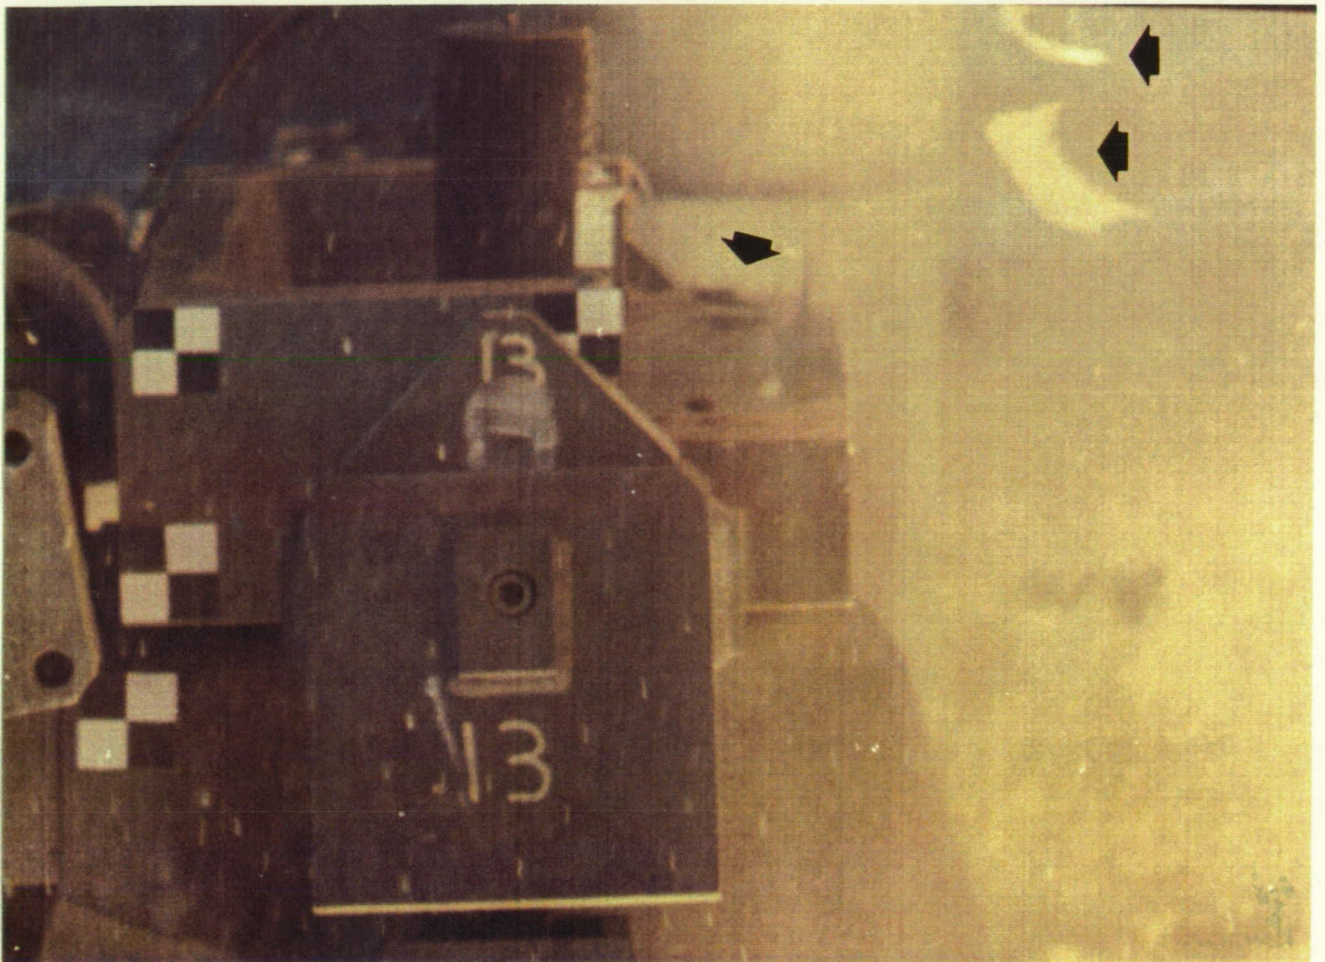
92 percent. The HDP #7 aft skirt bolt hole was broached along the hole edge closest to the centerline of the SRB. EPON shim material adjacent to the broached edge was missing.

A stud hang-up occurred on holddown post #7. The stud pulled loose EPON shim material (arrows), three pieces adjacent to the stud hole, from the aft skirt foot. No ordnance fragments fell from the HDP #7 DCS/stud hole.

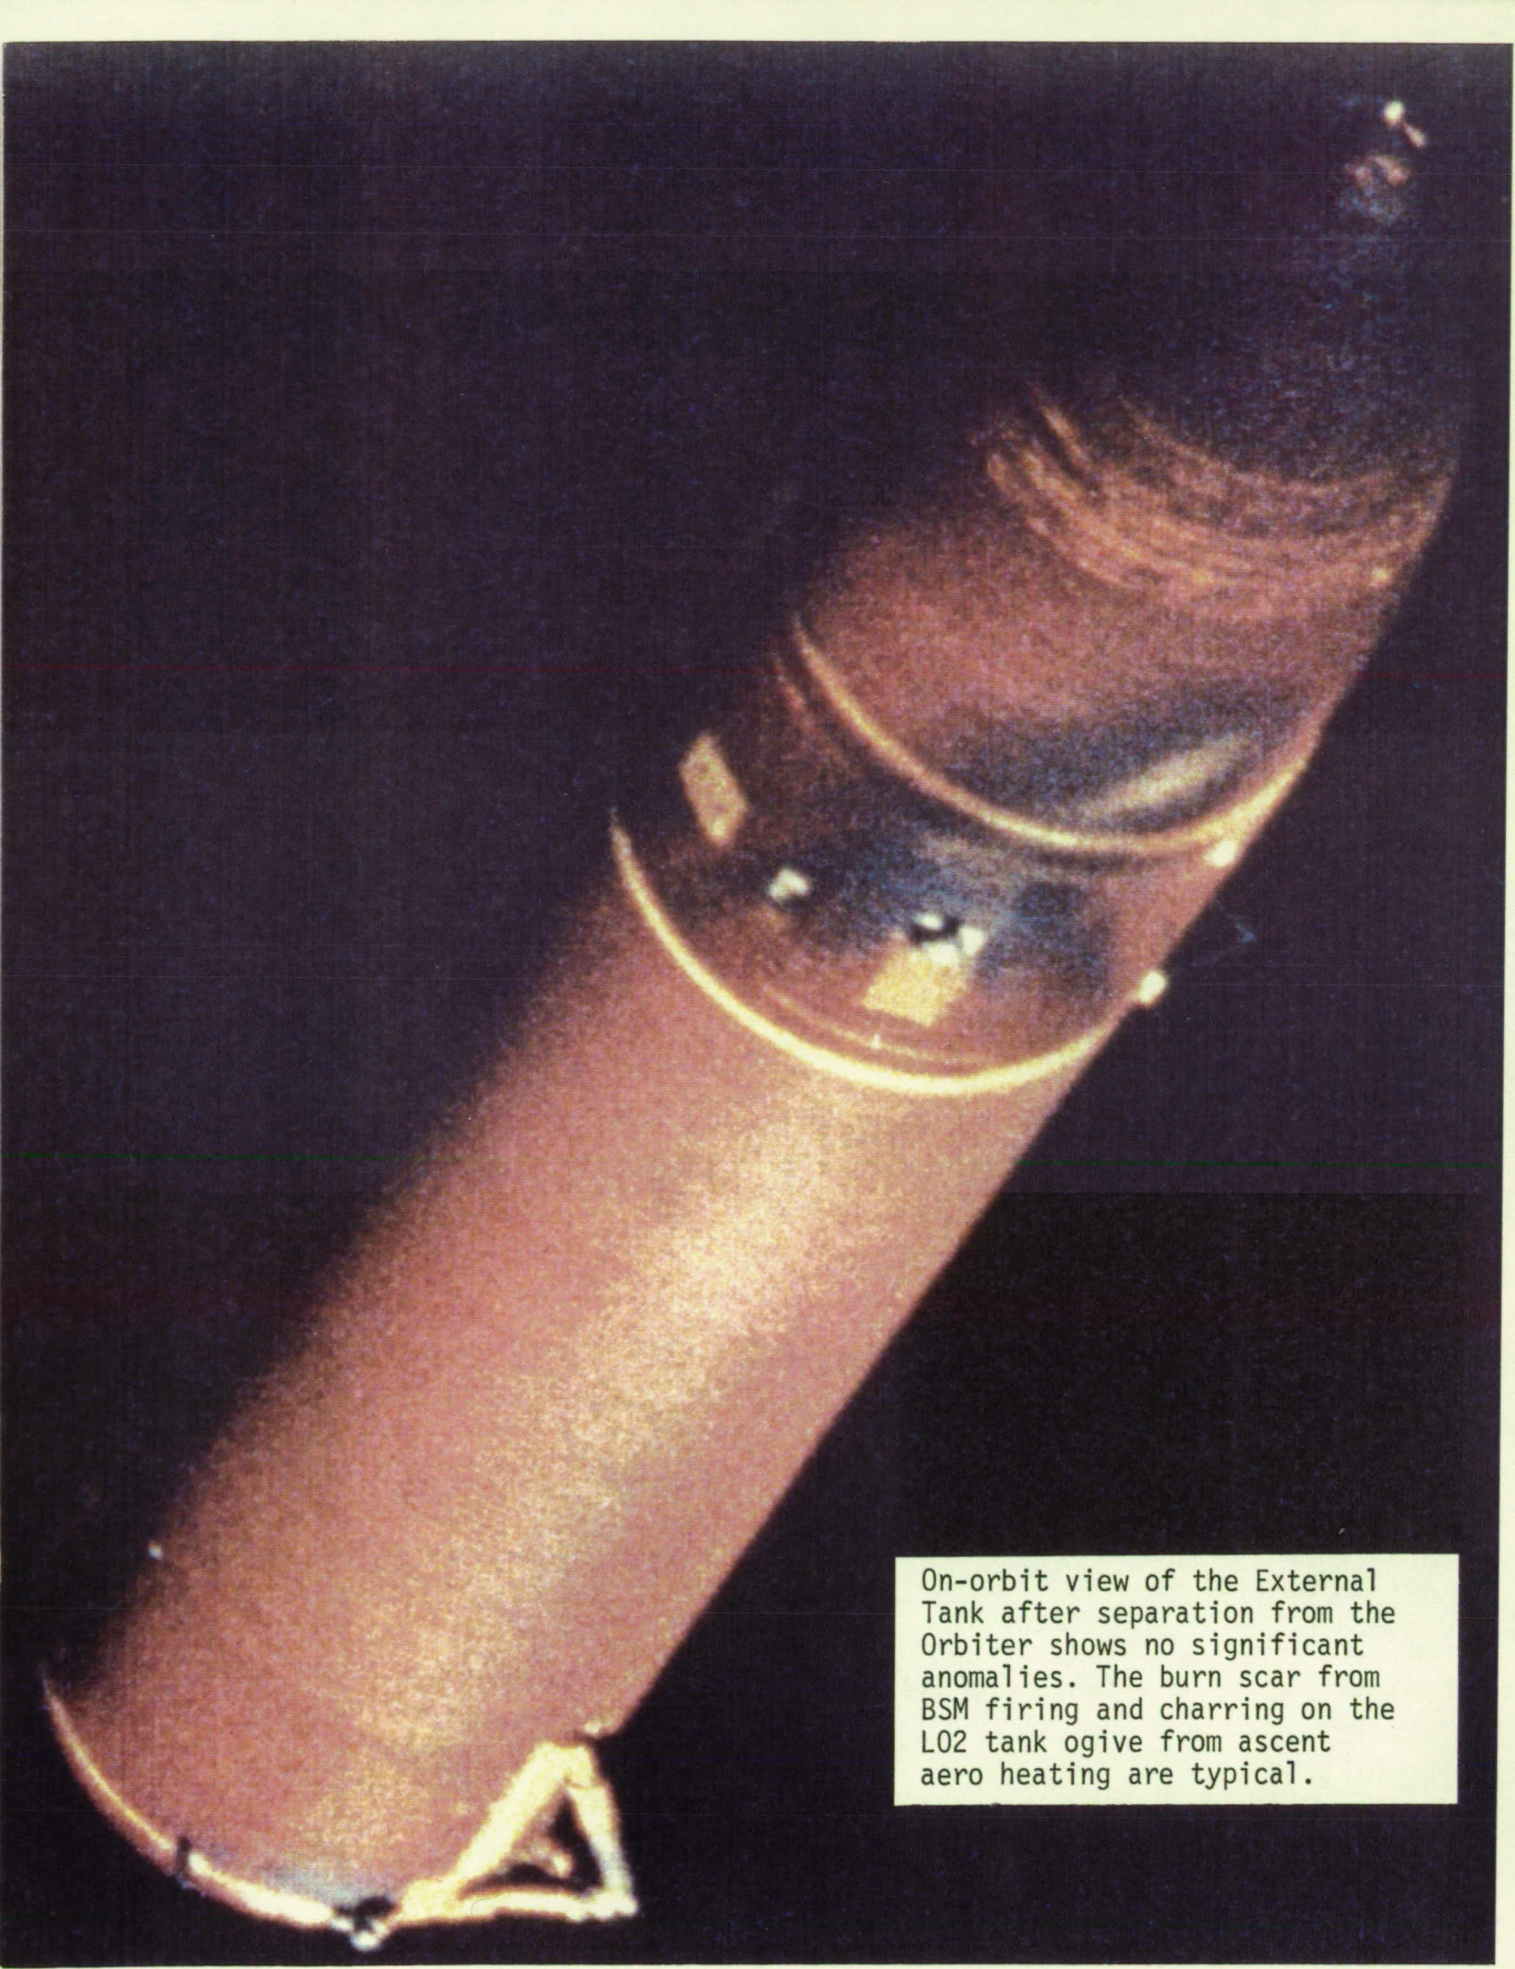
On-orbit view of the External Tank after separation from the Orbiter shows no significant anomalies. The burn scar from BSM firing and charring on the LO₂ tank ogive from ascent aero heating are typical.

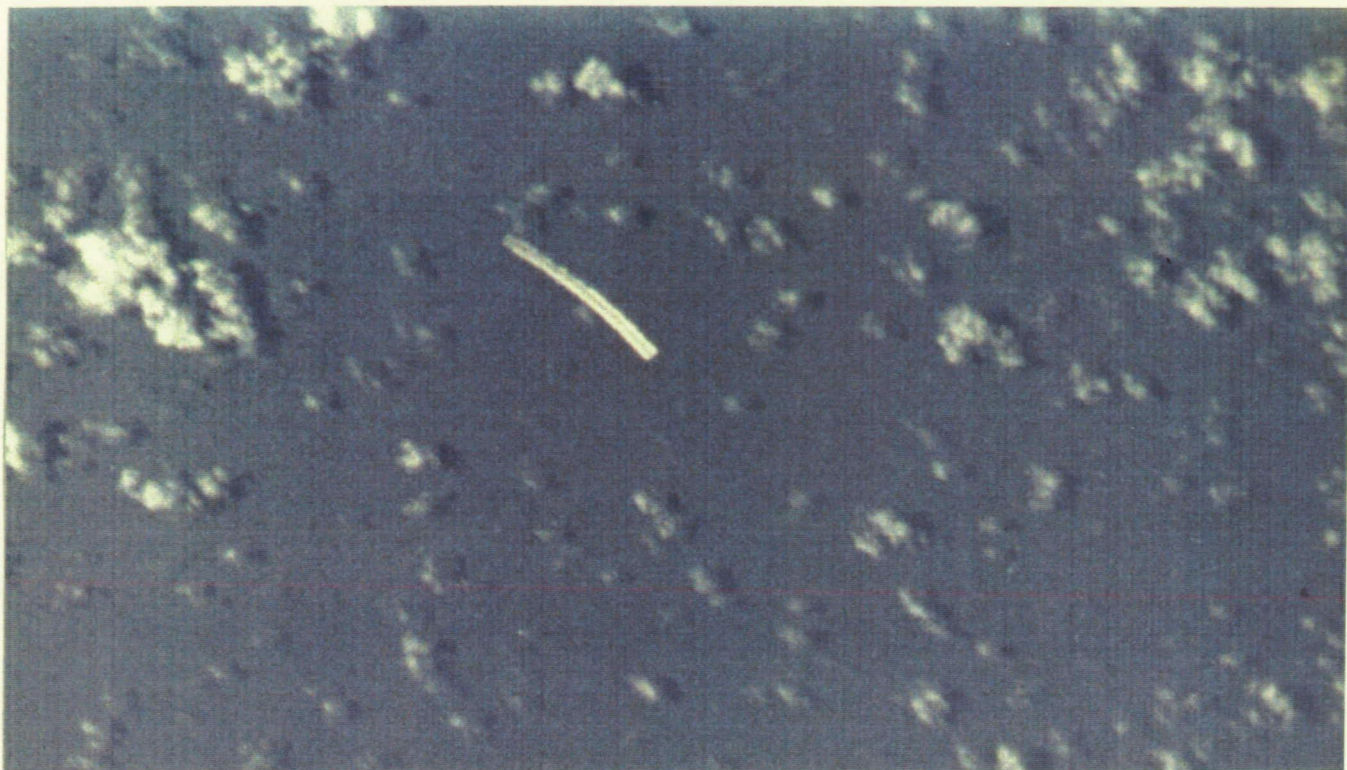
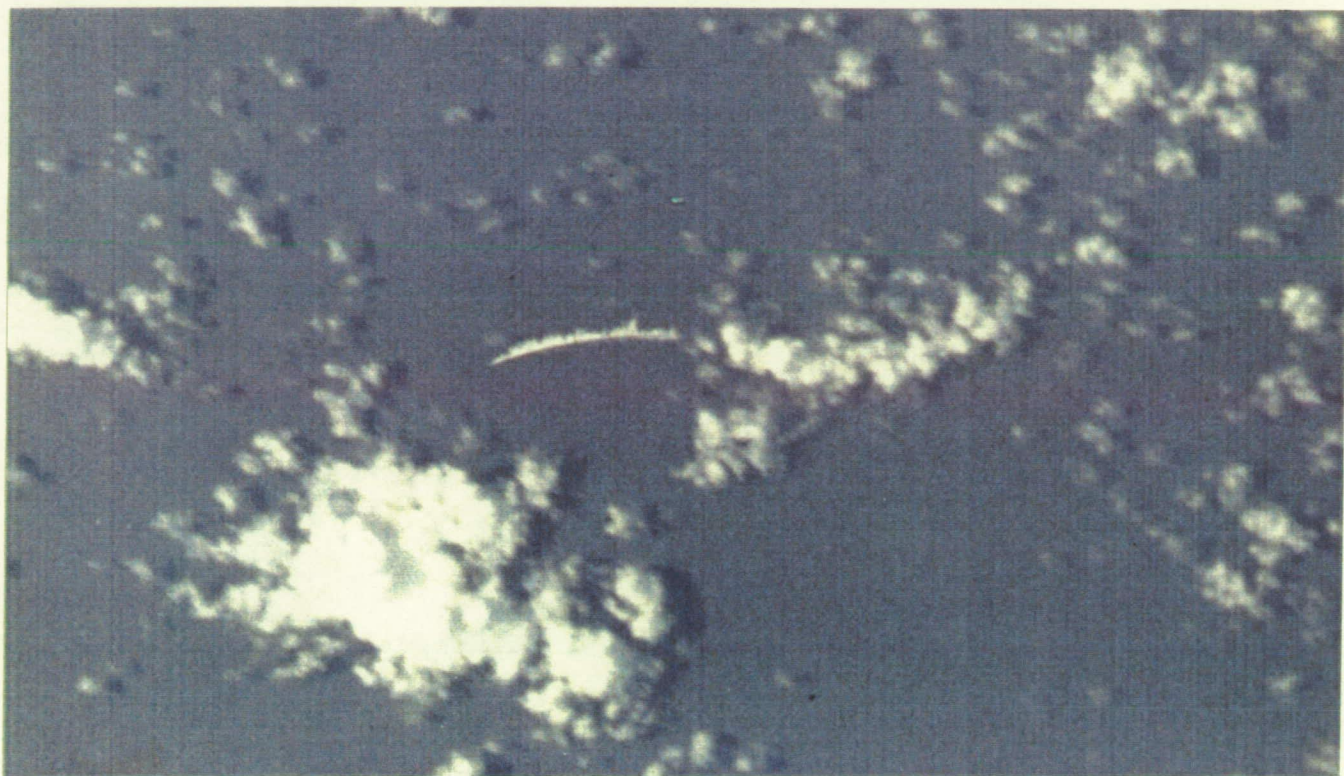
Shortly after TRDSS/IUS deployment, a light-colored, curved object with a smooth concave side and rough, textured convex side appeared to originate from the aft end of the Orbiter. Similar floating objects have been observed previously on STS-35 and STS-41. The most likely candidate for the object is frozen oxygen that had adhered to one of the SSME nozzles during the MPS dump.

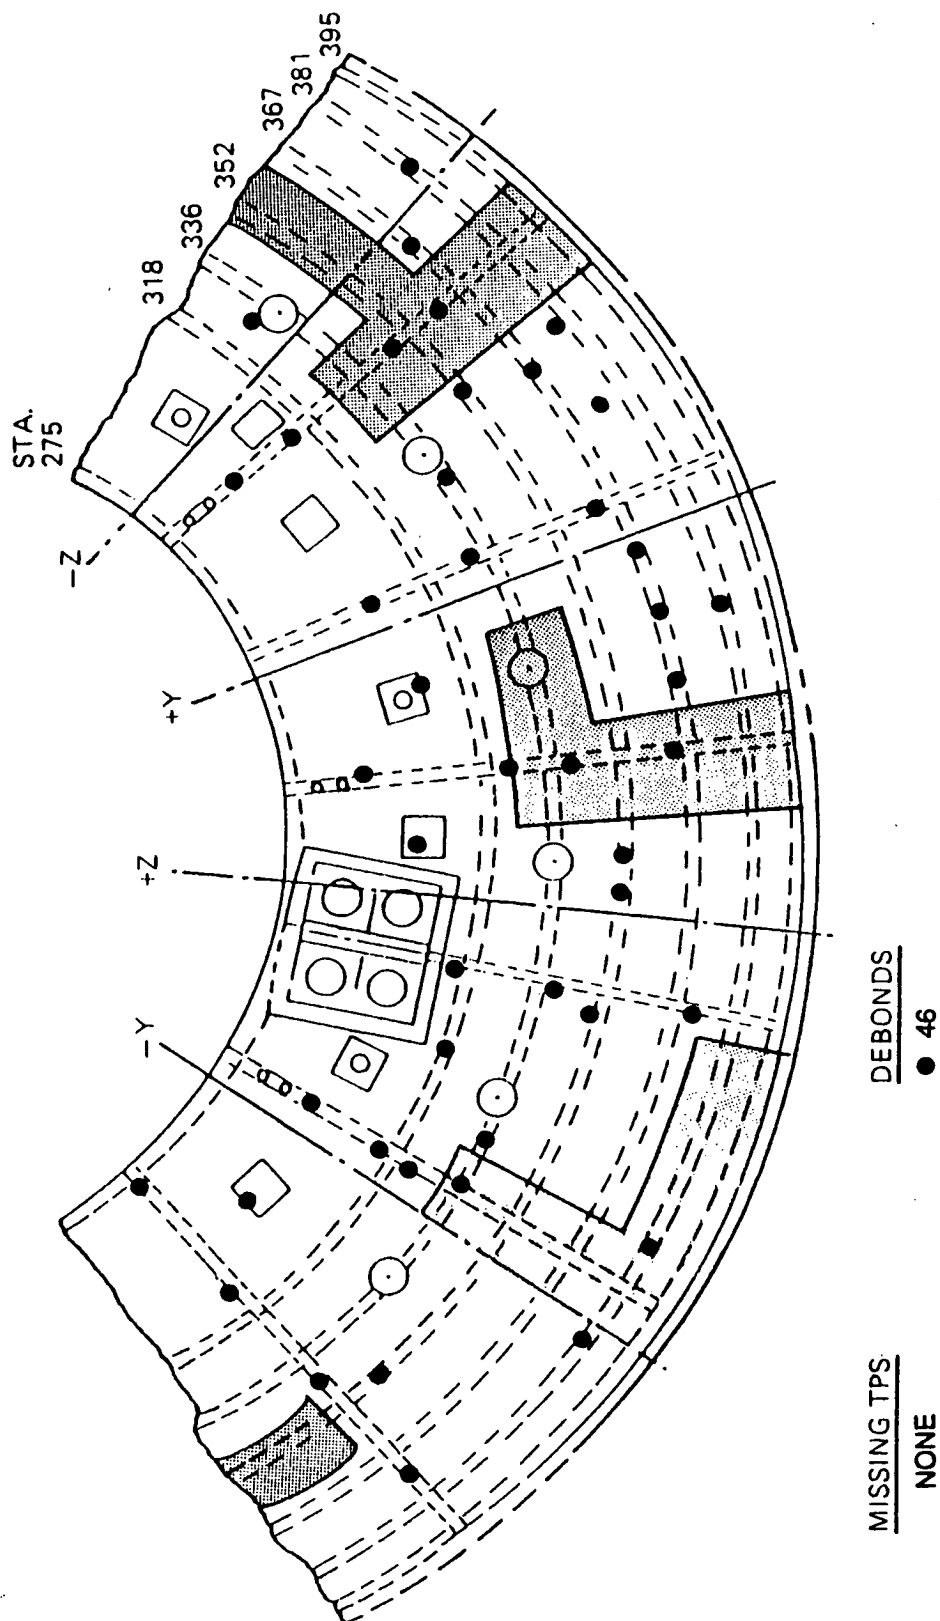
FIGURE 9. RIGHT SRB FRUSTUM

The RH frustum was missing no TPS but had 46 MSA-2 debonds over fasteners. There was minor localized blistering of the Hypalon paint (Figure 9). The BSM covers were locked in the open position, but the two LH covers were bent upward by parachute riser entanglement.

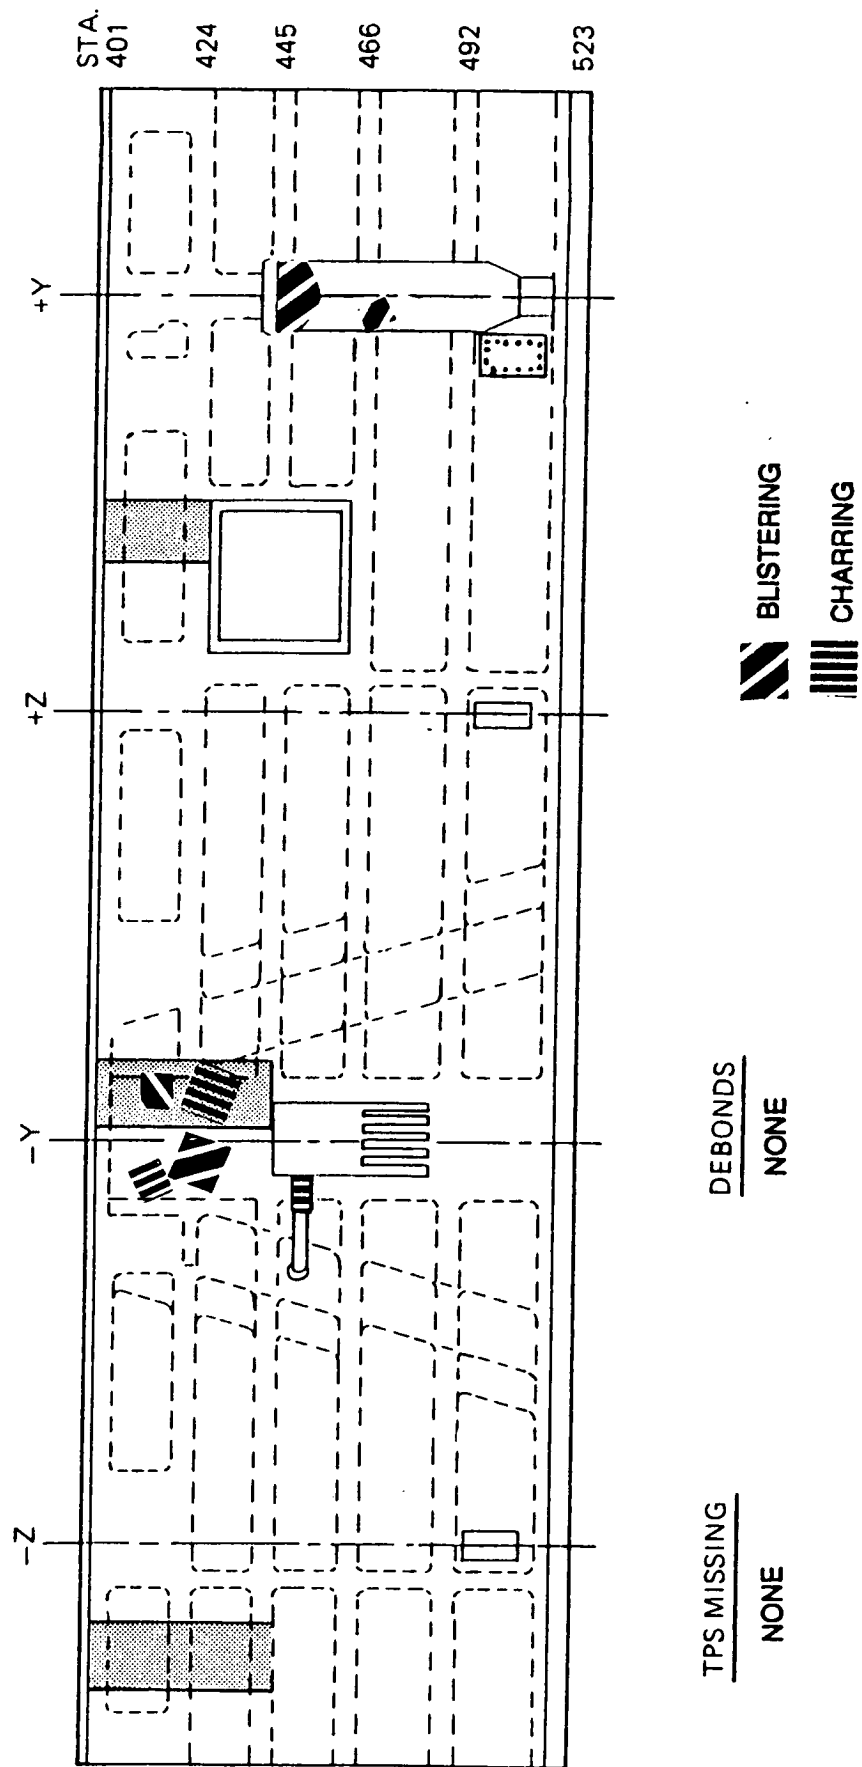
FIGURE 10. RIGHT SRB FWD SKIRT

The RH forward skirt exhibited no debonds or missing TPS. The phenolic plates on both RSS antennae were intact. The forward separation bolt and electrical cables appeared to have separated cleanly. No pins were missing from the frustum severance ring. Minor blistering of the Hypalon paint occurred forward of the ET/SRB attach point (Figure 10).

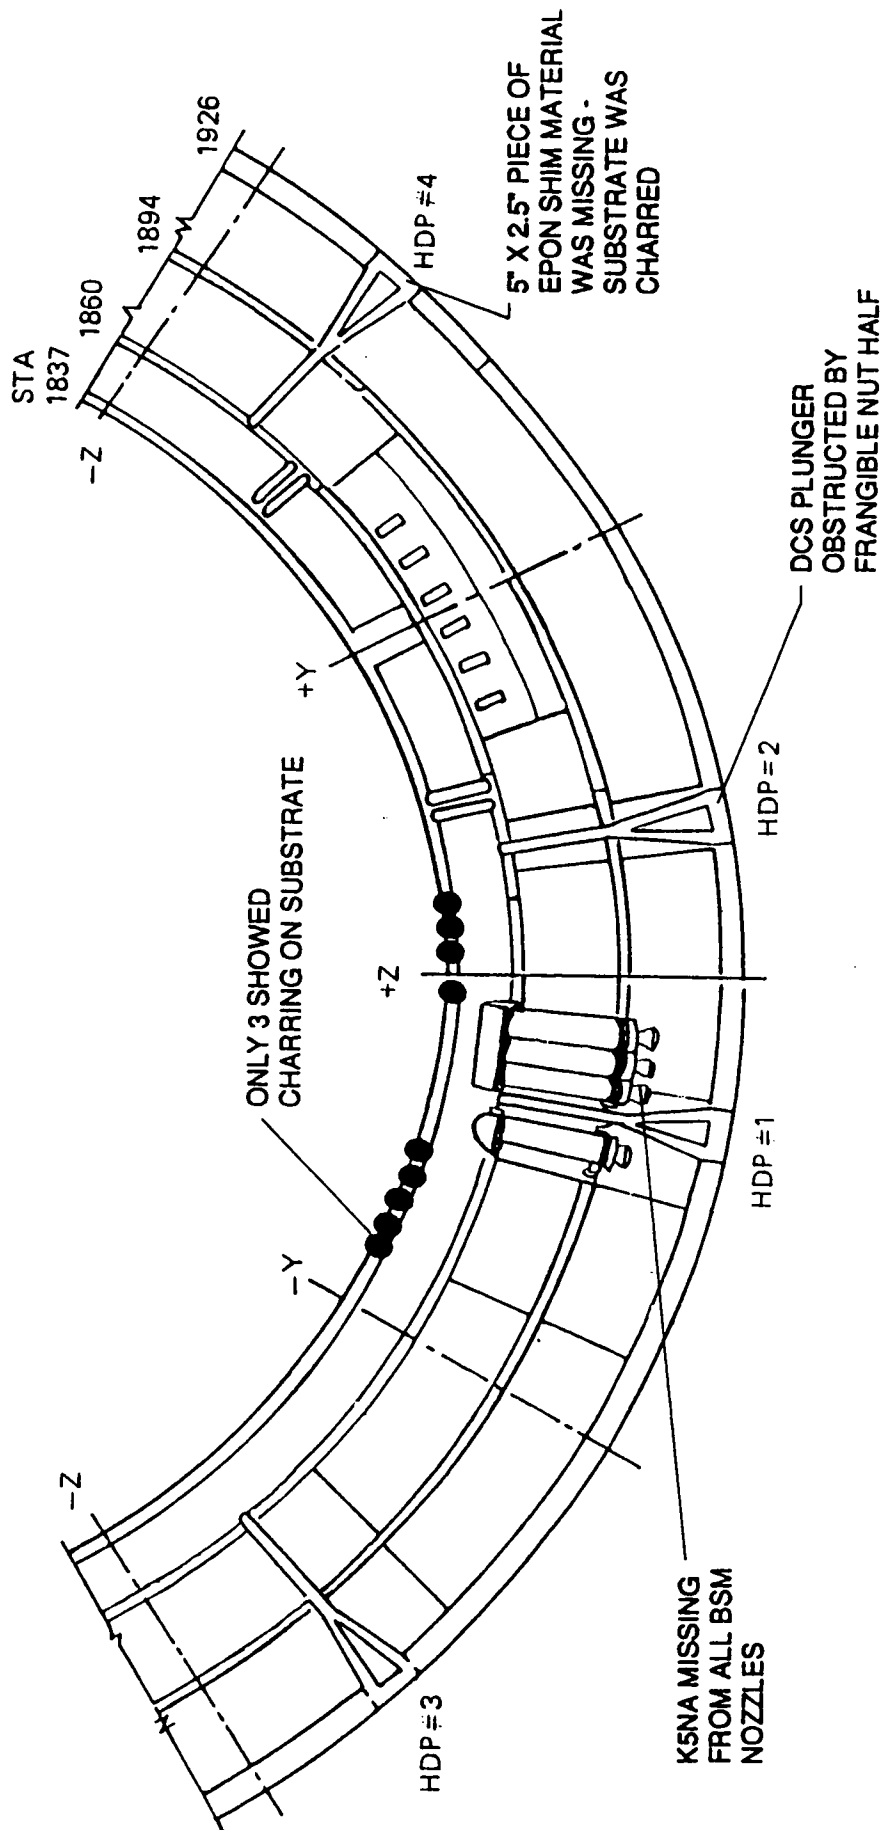
FIGURE 11. RIGHT SRB AFT SKIRT EXTERIOR TPS

The phenolic material on the kick ring delaminated at only a few locations. Three K5NA protective domes were lost from bolt heads on the aft side of the phenolic kick ring near HDP #3 prior to water impact. The aft skirt acreage TPS was in good condition (Figure 11). K5NA was missing from all of the aft BSM nozzles. Three of four HDP Debris Containment System (DCS) plungers were seated properly. The HDP #2 plunger was obstructed by a frangible nut half. This was the second flight utilizing the optimized link. All of the HDP #3 EPON shim material was intact. Most of the HDP #4 EPON shim material was lost at water impact except for a 5"x2.5" area, which showed a charred substrate.

● MISSING K5NA PROTECTIVE DOMES

NOTES:
TYPICAL CHARRING & BLISTERING OF HYPALON
PAINT OCCURRED ON AFT SKIRT ACREAGE

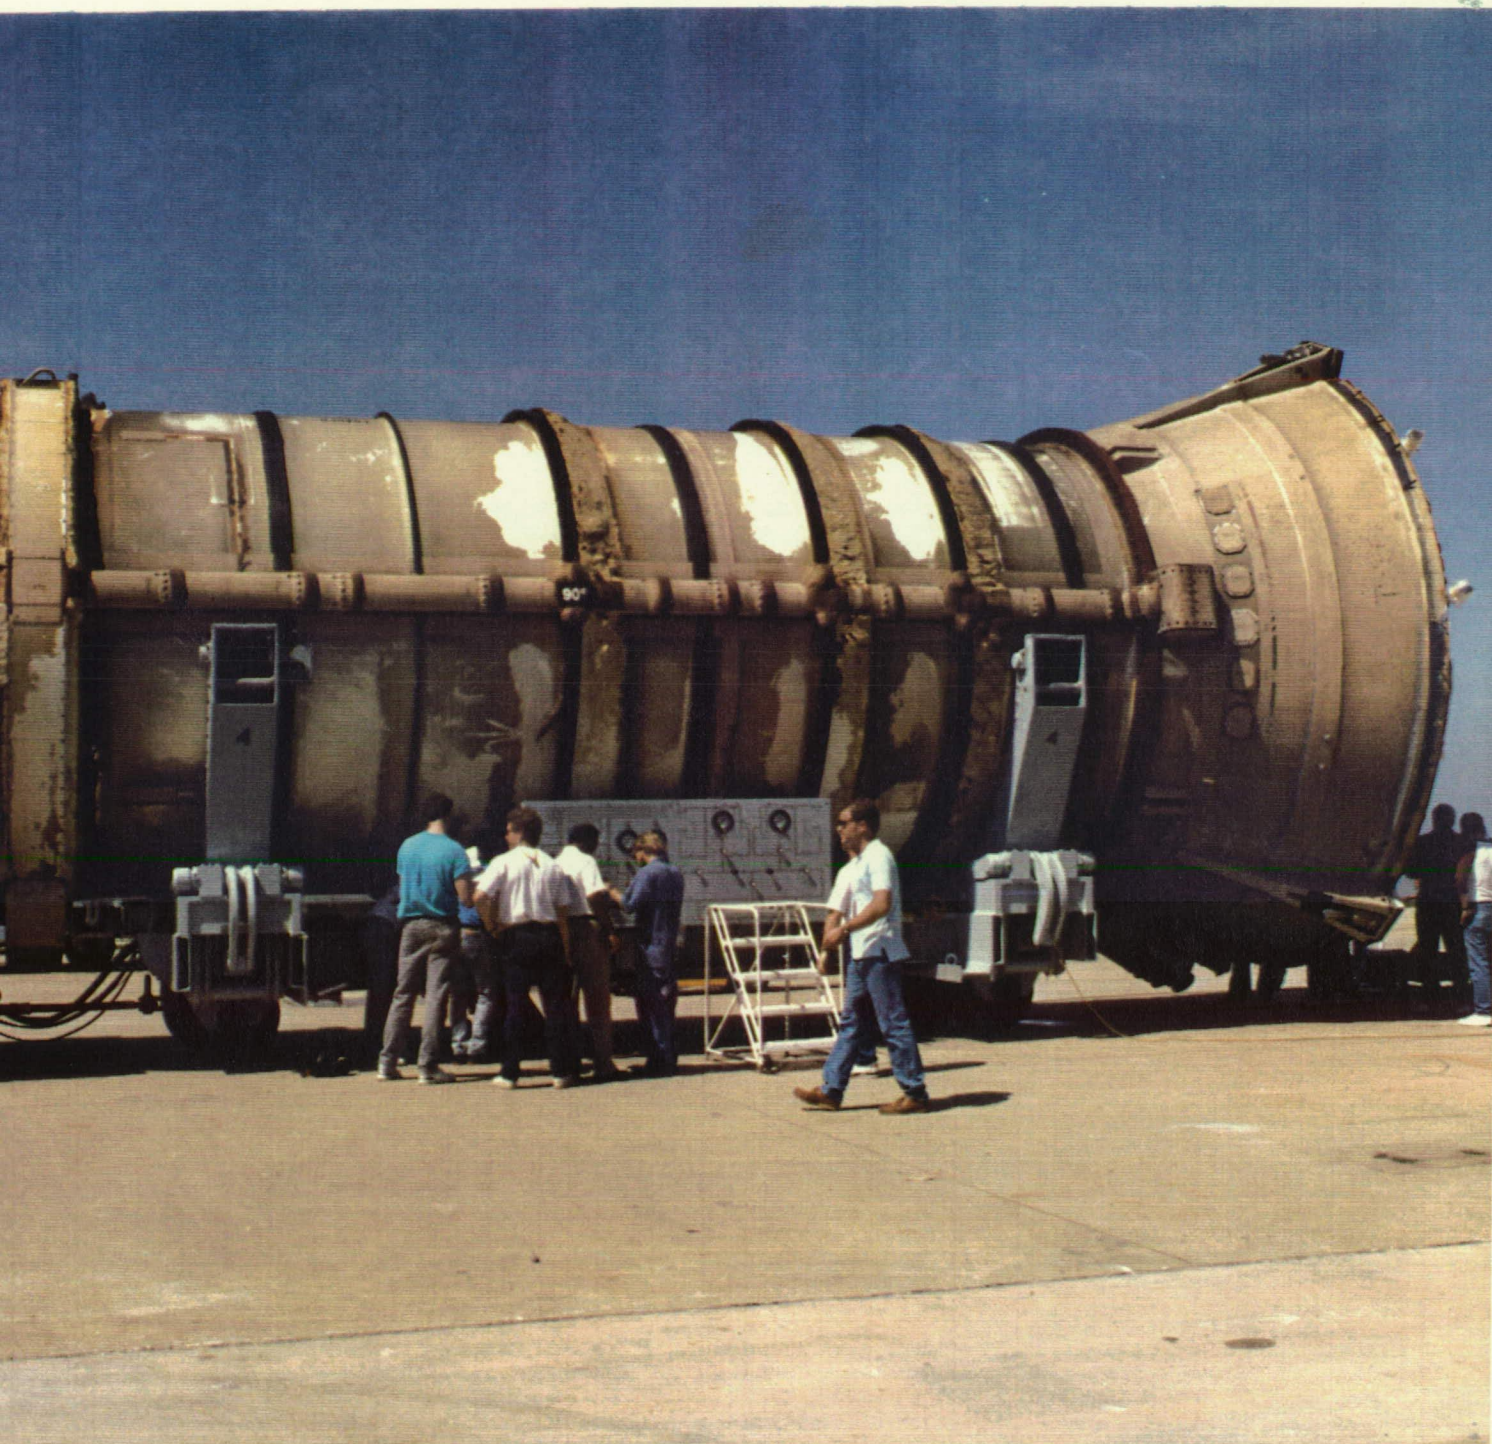
Post flight condition of the RH aft booster. The aft skirt
accreage TPS was in good condition.
